**Flood Control Project Maintenance  
Levee Inspections**

**2015 Channel Summary Report**

## San Joaquin County Flood Control and Water Conservation District

### Duck Creek Diversion Channel

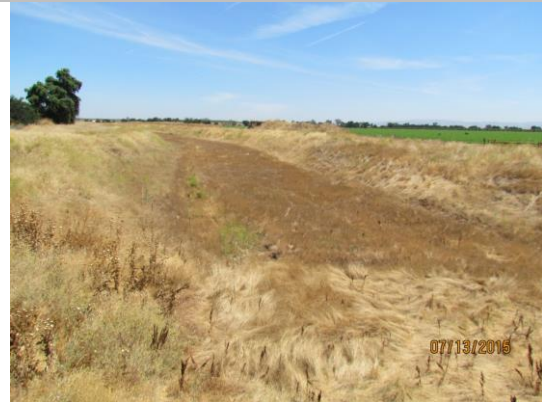
Photo 1 of 1 : CH\_2015\_NA0017\_43\_11\_20150817\_00015.jpg

Inspector Comments: The Minimal vegetation in the channel doesn't appear to obstruct the flow of the channel.

View of the vegetation in the channel looking upstream.

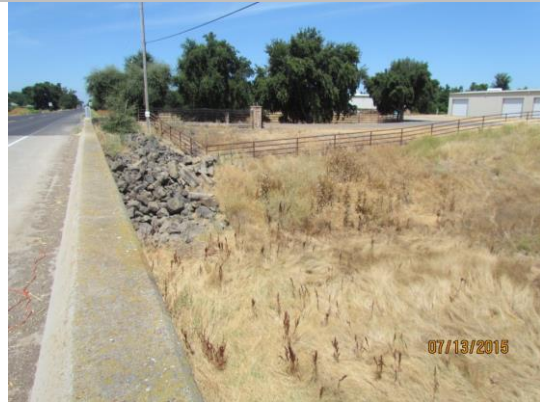
Photo 1 of 2 : CH\_2015\_NA0017\_43\_14\_20150817\_00017.jpg

Rating **	A	Issue No.	14	GPS Lat/Long
Issue Type +	Ma	Location *		37.930250 °
Category	Rivers, Channels & Designated Flood			-120.991220 °
Item	Revetments			
DWR ID	DWR_NA0017_43_c _ 2012_14			
Action/Comments				
Inspector Comments: Existing riprap appears to be properly maintained.

View of the revetments on the right bank of the channel looking upstream.

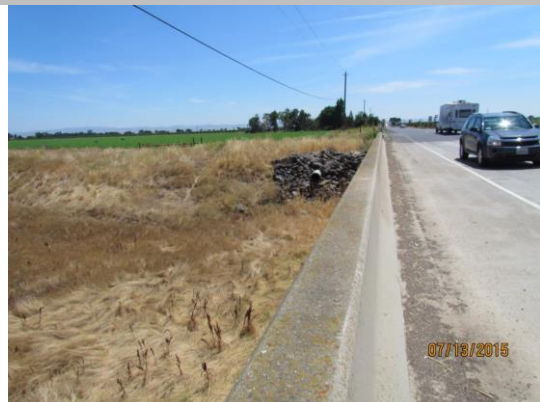
Photo 2 of 2 : CH\_2015\_NA0017\_43\_14\_20150817\_00016.jpg

View of the revetments on the left bank of the channel looking upstream.

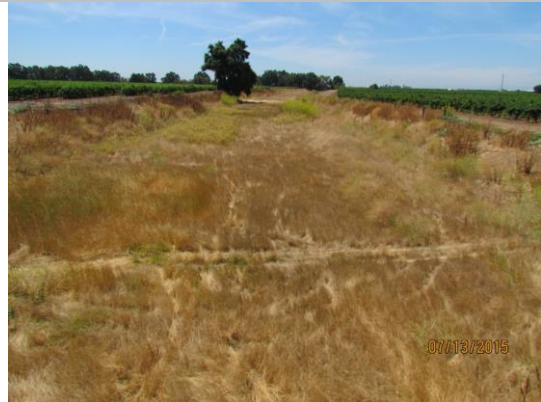
Photo 1 of 1 : CH\_2015\_NA0017\_43\_16\_20150817\_00018.jpg

Rating **	A	Issue No.	16	GPS Lat/Long
Issue Type +	Ma	Location *		37.930250 °
Category	Rivers, Channels & Designated Flood			-120.991220 °
Item	Vegetation & Obstructions			
DWR ID	DWR_NA0017_43_c _ 2012_16			
Action/Comments				
Inspector Comments: Minimal vegetation is present in the channel but it doesn't appear to obstruct the flow of the channel.

View of the vegetation growth looking downstream in the channel.

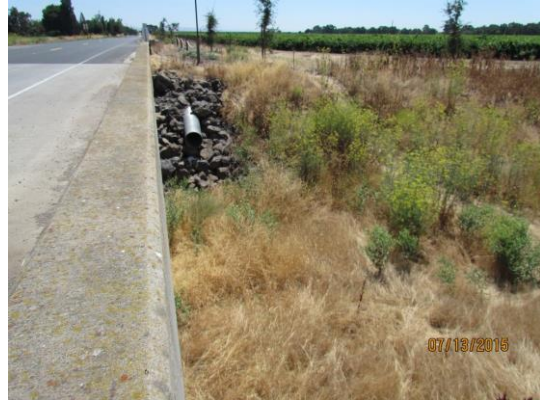
Photo 1 of 2 : CH\_2015\_NA0017\_43\_19\_20150817\_00019.jpg

Check Point / View				
Farmington Rd/ Hwy 4 / Down (cont)				
Rating **	A	Issue No.	19	GPS Lat/Long
Issue Type +	Ma	Location *		37.929807 °
Category	Rivers, Channels & Designated Flood			-120.991183 °
Item	Revetments			
DWR ID	DWR_NA0017_43_c _ 2012_19			
Action/Comments				
Inspector Comments: Existing riprap appears to be properly maintained.

View of the revetments on the left bank of the channel looking downstream.

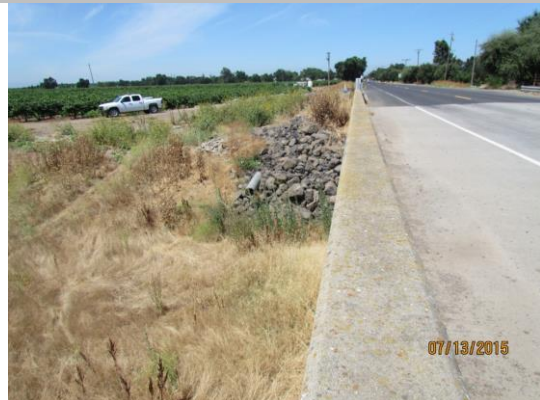
Photo 2 of 2 : CH\_2015\_NA0017\_43\_19\_20150817\_00020.jpg

View of the revetments on the right bank of the channel looking downstream.

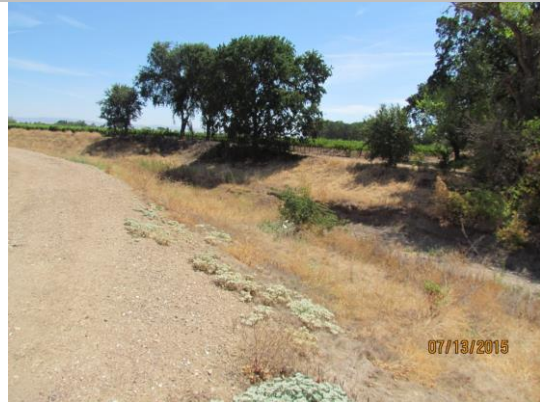
Photo 1 of 4 : CH\_2015\_NA0017\_43\_21\_20150817\_00022.jpg

View of the channel looking upstream during 2015 inspection.

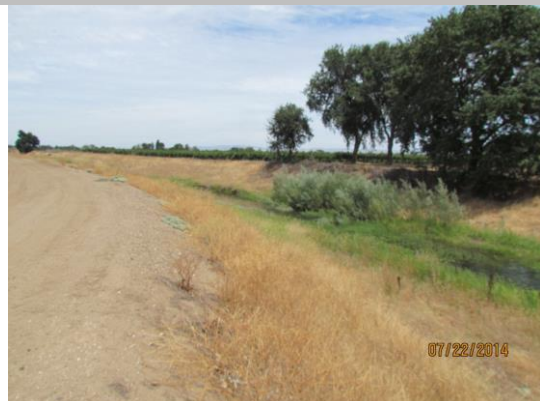
Photo 2 of 4 : CH\_2015\_NA0017\_43\_21\_20150710\_00009.jpg

View of the channel looking upstream during 2014 inspection.

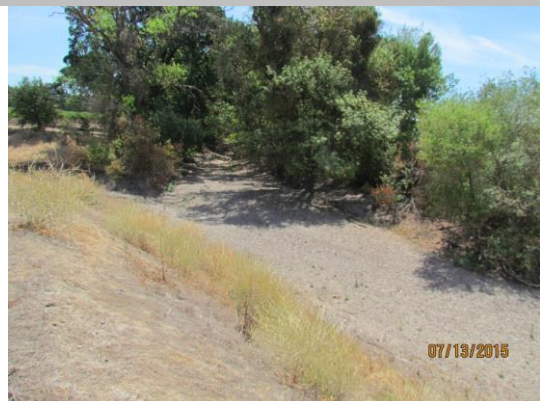
Photo 3 of 4 : CH\_2015\_NA0017\_43\_21\_20150817\_00021.jpg

View of the confluence during 2015 inspection.

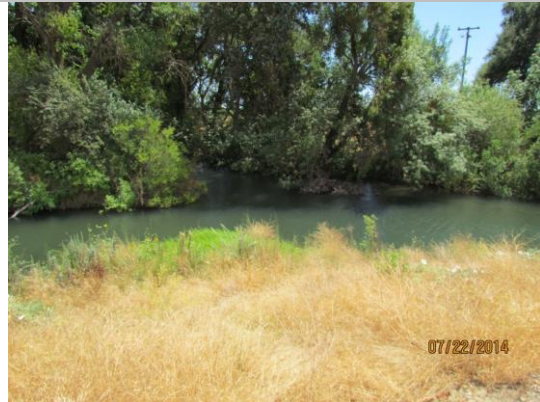
Photo 4 of 4 : CH\_2015\_NA0017\_43\_21\_20150710\_00011.jpg

Inspector Comments: Vegetation growth in the channel doesn't appeared to impede the flow.

View of the confluence during 2014 inspection.

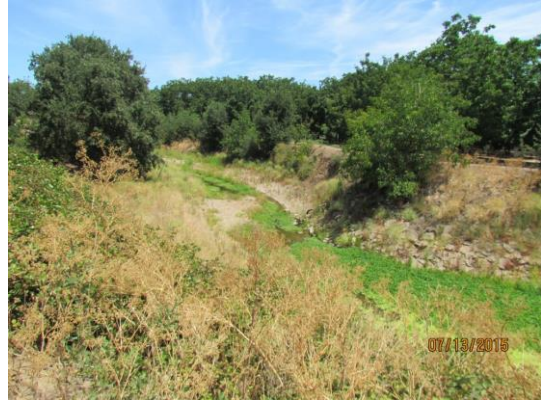
Photo 1 of 1 : CH\_2015\_NA0017\_42\_6\_20150818\_00044.jpg

Rating **	A	Issue No.	6	GPS Lat/Long
Issue Type +	Ma	Location *		37.919430 °
Category	Rivers, Channels & Designated Flood			-121.034800 °
Item	Vegetation & Obstructions			
DWR ID	DWR_NA0017_42_c _ 2012_6			
Action/Comments				
Inspector Comments: No vegetation is obstructing the flow of the channel.

View of the vegetation on the upstream of the channel.

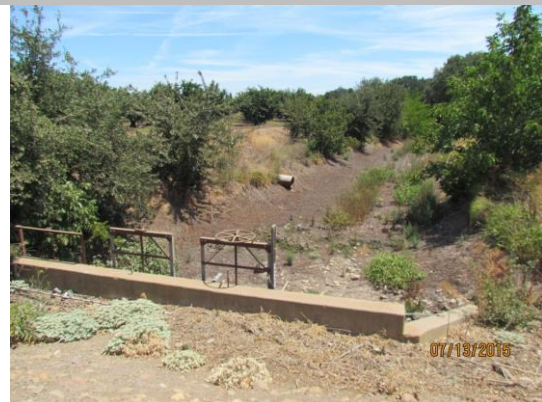
Photo 1 of 2 : CH\_2015\_NA0017\_42\_11\_20150818\_00045.jpg

Inspector Comments: Vegetation will not impede the flow of the channel.

View of the channel looking upstream during 2015 inspection.

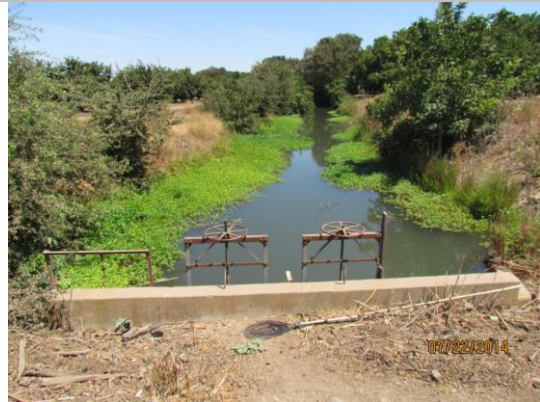
Photo 2 of 2 : CH\_2015\_NA0017\_42\_11\_20150710\_00004.jpg

Rating **	A	Issue No.	11 (cont)	GPS Lat/Long
Issue Type +	Ma	Location *		37.920600 °
Category	Rivers, Channels & Designated Flood			-121.037920 °
Item	Vegetation & Obstructions			
DWR ID	DWR_NA0017_42_c _ 2012_11			
Action/Comments				
Inspector Comments: Vegetation will not impede the flow of the channel.

View of vegetation looking upstream during 2014 inspection.

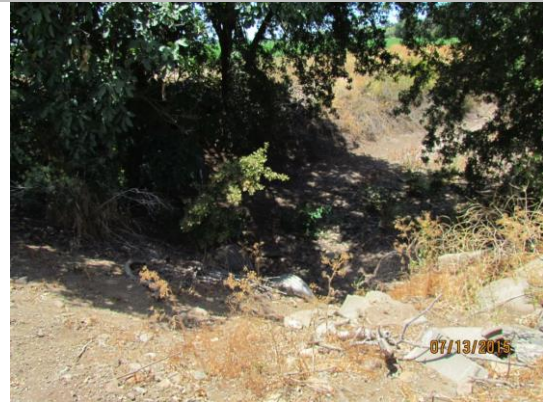
Photo 1 of 1 : CH\_2015\_NA0017\_42\_16\_20150818\_00047.jpg

Rating **	A	Issue No.	16	GPS Lat/Long
Issue Type +	Ma	Location *		37.920584 °
Category	Rivers, Channels & Designated Flood			-121.037914 °
Item	Vegetation & Obstructions			
DWR ID	DWR_NA0017_42_c _ 2012_16			
Action/Comments				
Inspector Comments: Walnut tree exists on left side of the shoulder. It doesn't obstructed the flow, but it could fall down in the creek.

View of the channel looking downstream during 2015 inspection.

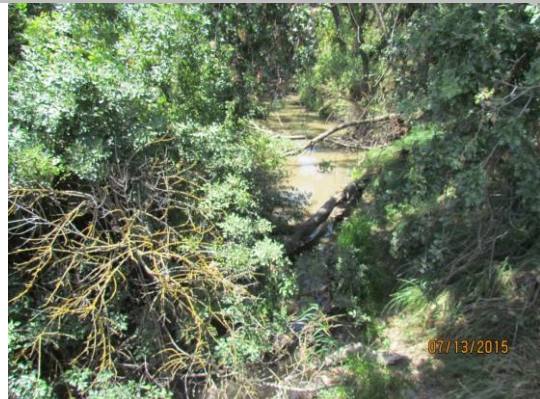
Photo 1 of 1 : CH\_2015\_NA0017\_42\_26\_20150818\_00049.jpg

Check Point / View				
Van Allen Rd / Down				
Rating **	M	Issue No.	26	GPS Lat/Long
Issue Type +	Ma	Location *		37.918960 °
Category	Rivers, Channels & Designated Flood			-121.056260 °
Item	Vegetation & Obstructions			
DWR ID	DWR_NA0017_42_c _ 2012_26			
Action/Comments				
Inspector Comments: Various lengths of logs, and vegetation growth appeared to impede the flow of the channel.

View of heavy vegetation looking downstream of the channel.

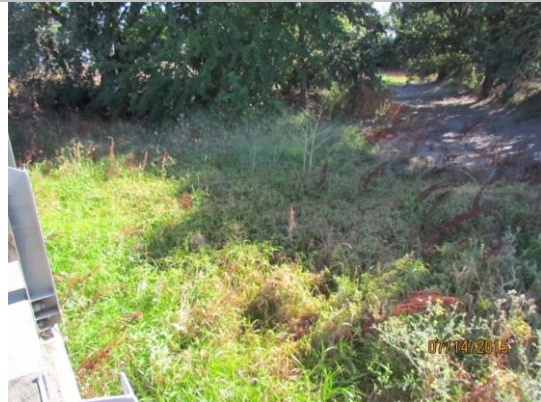
Photo 1 of 2 : CH\_2015\_NA0017\_42\_31\_20150818\_00051.jpg

View of the channel looking upstream during 2015 inspection.

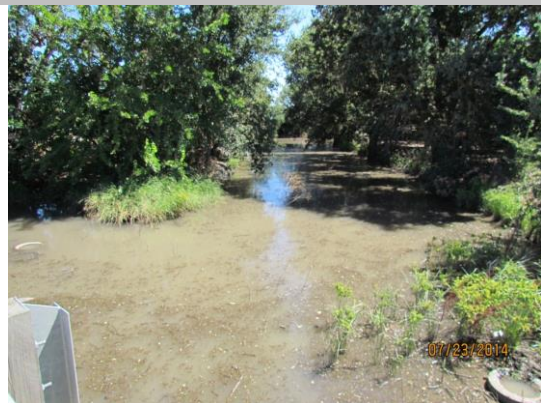
Photo 2 of 2 : CH\_2015\_NA0017\_42\_31\_20150710\_00011.jpg

View of upstream of the channel during 2014 inspection.

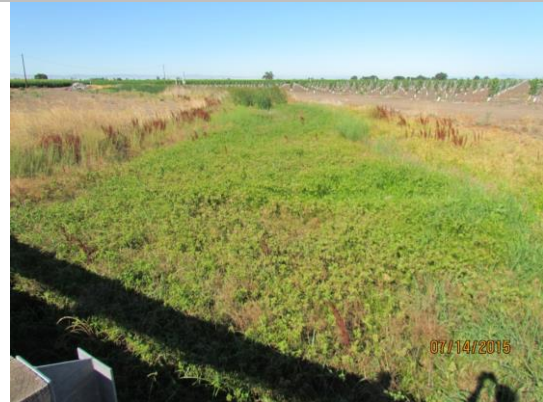
Photo 1 of 1 : CH\_2015\_NA0017\_42\_36\_20150818\_00052.jpg

Rating **	A	Issue No.	36	GPS Lat/Long
Issue Type +	Ma	Location *		37.921460
Category	Rivers, Channels & Designated Flood			-121.147570
Item	Vegetation & Obstructions			
DWR ID	DWR_NA0017_42_c _ 2012_36			
Action/Comments				
Inspector Comments: Minimal vegetation on the channel should not obstruct the flow.

View of the channel looking downstream.

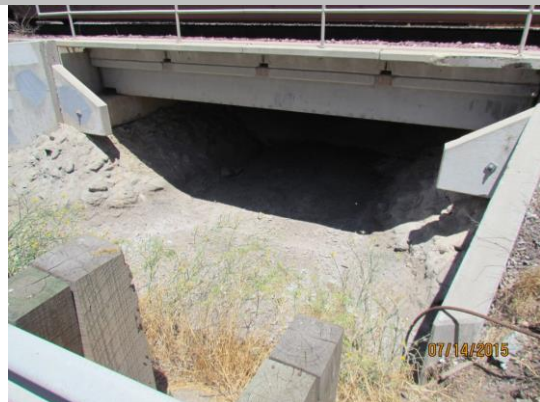
Photo 1 of 2 : CH\_2015\_NA0017\_42\_41\_20150818\_00053.jpg

Inspector Comments: Minimal vegetation on the channel should not impede the flow.

View of upstream of the channel during 2015 inspection.

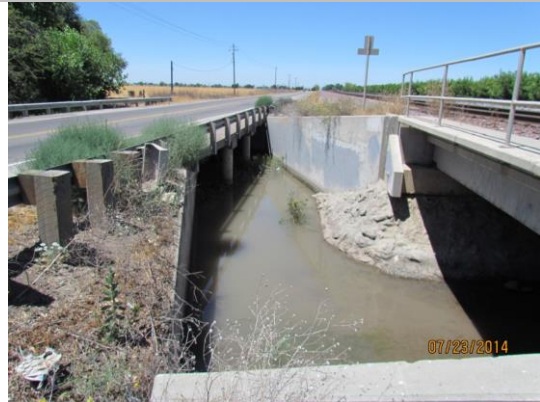
Photo 2 of 2 : CH\_2015\_NA0017\_42\_41\_20150710\_00015.jpg

Inspector Comments: Minimal vegetation on the channel should not impede the flow.

View of upstream of the channel during 2014 inspection.

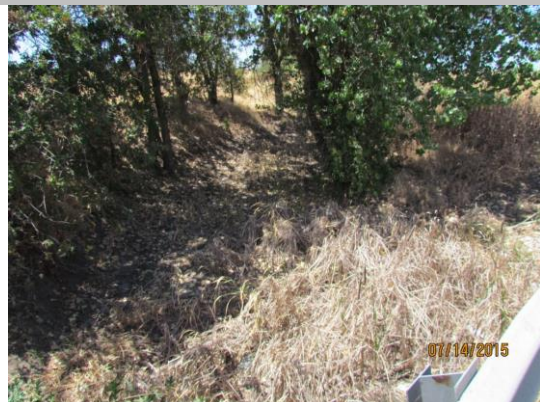
Photo 1 of 1 : CH\_2015\_NA0017\_42\_46\_20150818\_00054.jpg

Inspector Comments: Vegetation growth may obstruct the flow of the channel.

View of vegetation on the downstream of the channel.

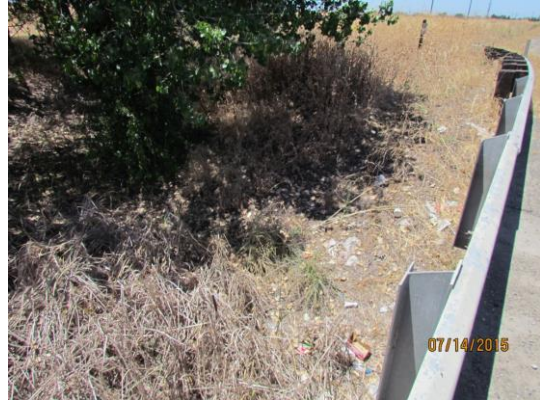
Photo 1 of 1 : CH\_2015\_NA0017\_42\_50\_20150818\_00055.jpg

Inspector Comments: Trash and debris were present in the channel during inspection, but it may not impede the flow of the channel.

View of debris in the downstream end of the channel.

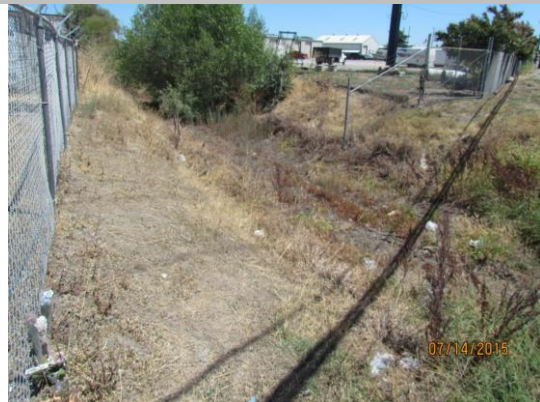
Photo 1 of 2 : CH\_2015\_NA0017\_42\_51\_20150818\_00056.jpg

Inspector Comments: Minimal vegetation on the channel will not impede the flow of the channel.

View of the vegetation on the channel looking upstream during 2015 inspection.

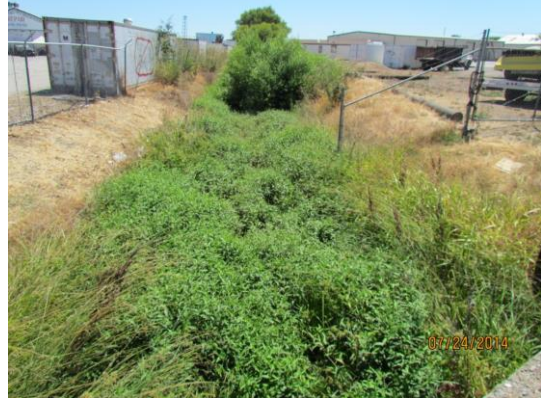
Photo 2 of 2 : CH\_2015\_NA0017\_42\_51\_20150710\_00019.jpg

Inspector Comments: Minimal vegetation on the channel will not impede the flow of the channel.

View of the vegetation on the channel looking upstream during 2014 inspection.

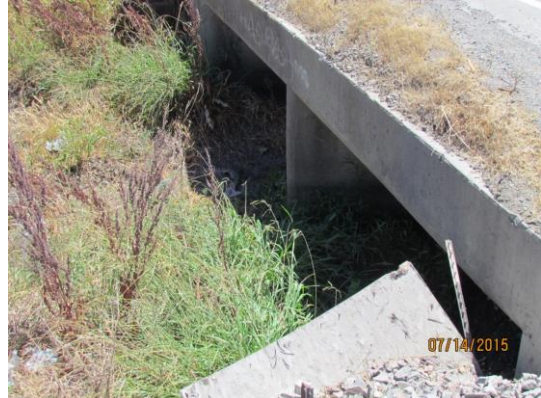
Photo 1 of 1 : CH\_2015\_NA0017\_42\_52\_20150818\_00057.jpg

Inspector Comments: Sedimentation is present at this location.

View of sedimentation on the upstream of the channel.

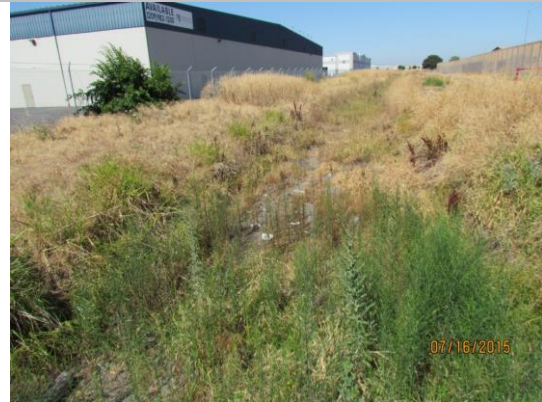
Photo 1 of 1 : CH\_2015\_NA0017\_42\_56\_20150819\_00059.jpg

Inspector Comments: Minimal vegetation does not impede the flow on the channel.

View of the downstream end of the channel.

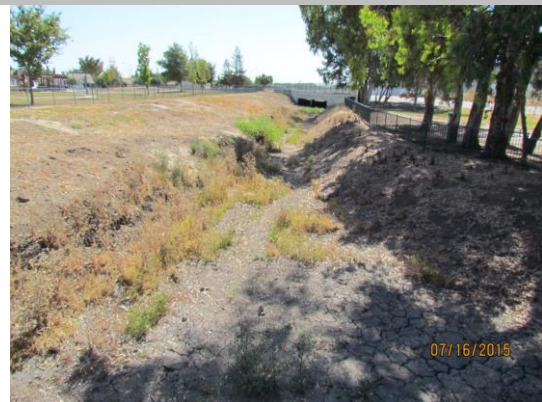
Photo 1 of 2 : CH\_2015\_NA0017\_42\_61\_20150819\_00060.jpg

Inspector Comments: Minimal vegetation may not impede the flow of the channel.

View of the channel looking upstream during 2015 inspection.

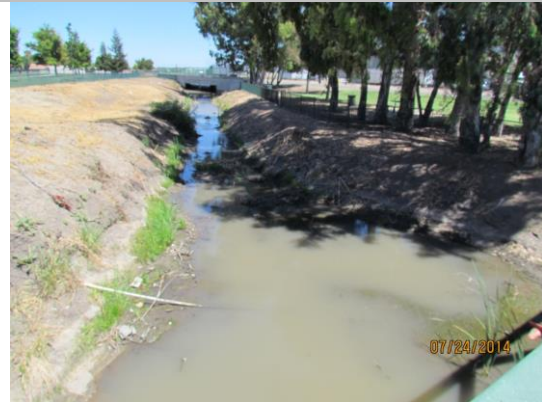
Photo 2 of 2 : CH\_2015\_NA0017\_42\_61\_20150710\_00024.jpg

Inspector Comments: Minimal vegetation may not impede the flow of the channel.

View of the channel looking upstream during 2014 inspection.

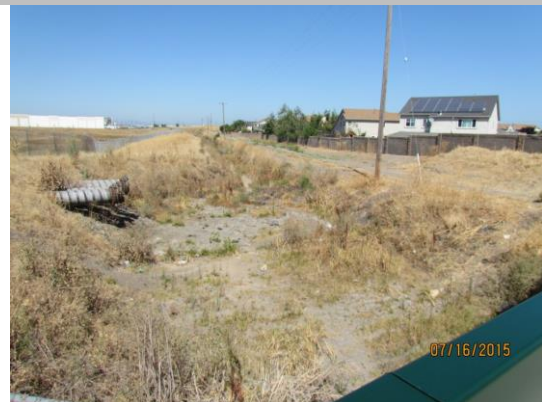
Photo 1 of 1 : CH\_2015\_NA0017\_42\_66\_20150819\_00061.jpg

Inspector Comments: Minimal vegetation may not impede the flow of the channel.

View of the channel looking downstream.

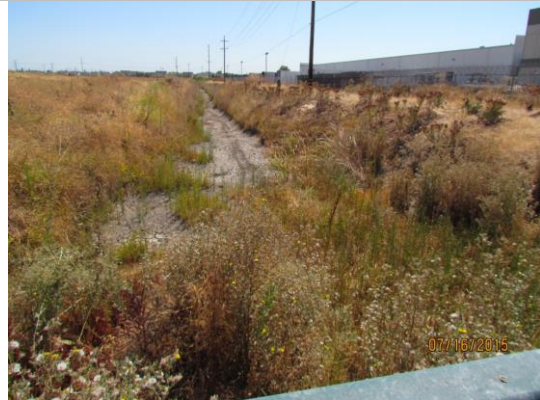
Photo 1 of 1 : CH\_2015\_NA0017\_42\_71\_20150819\_00062.jpg

Check Point / View				
South B Street / Up				
Rating **	M	Issue No.	71	GPS Lat/Long
Issue Type +	Ma	Location *		37.913716 °
Category	Rivers, Channels & Designated Flood			-121.247761 °
Item	Vegetation & Obstructions			
DWR ID	DWR_NA0017_42_c _ 2012_71			
Action/Comments				
Inspector Comments: Minimal vegetation is present in the channel.

View of vegetation on the channel looking upstream.

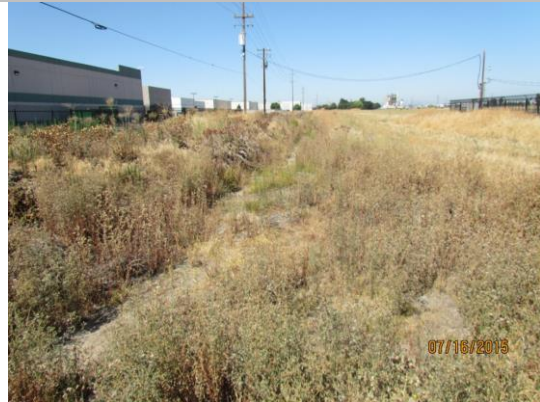
Photo 1 of 2 : CH\_2015\_NA0017\_42\_76\_20150819\_00063.jpg

Inspector Comments: Minimal vegetation on the channel may impede the flow.

View of the channel looking downstream on 2015 inspection.

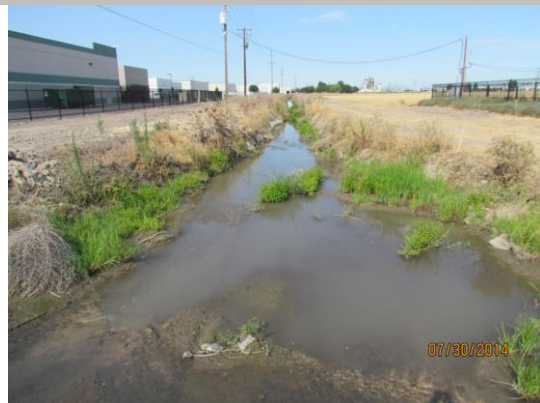
Photo 2 of 2 : CH\_2015\_NA0017\_42\_76\_20150710\_00030.jpg

View of the channel looking downstream on 2014 inspection.

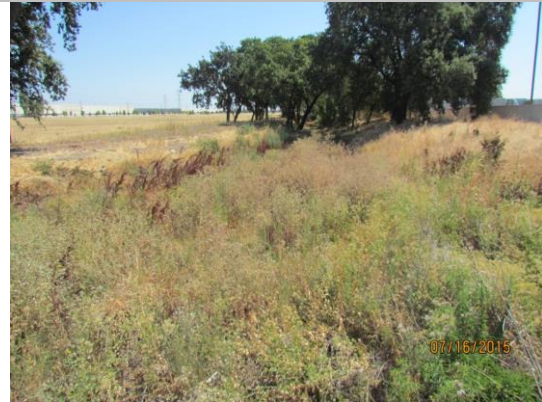
Photo 1 of 1 : CH\_2015\_NA0017\_42\_81\_20150819\_00064.jpg

Inspector Comments: Minimal vegetation may impede the flow of the channel.

View of the vegetation on the channel looking upstream.

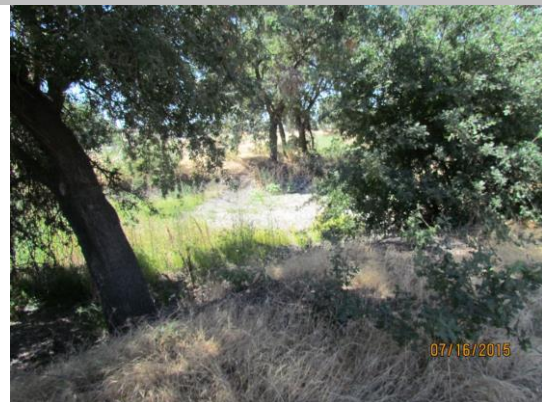
Photo 1 of 1 : CH\_2015\_NA0017\_42\_86\_20150819\_00065.jpg

Inspector Comments: Minimal vegetation and logs may impede the flow of the channel.

View of the channel looking downstream.

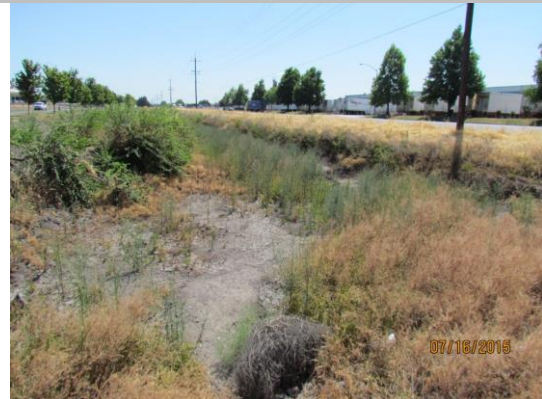
Photo 1 of 1 : CH\_2015\_NA0017\_42\_91\_20150819\_00066.jpg

Check Point / View				
Producers Drive / Up				
Rating **	A	Issue No.	91	GPS Lat/Long
Issue Type +	Ma	Location *		37.908433
Category	Rivers, Channels & Designated Flood			-121.269214
Item	Vegetation & Obstructions			
DWR ID	DWR_NA0017_42_c _ 2012_91			
Action/Comments				
Inspector Comments: Minimal vegetation may not impede the flow of the channel.

View of the channel looking upstream.

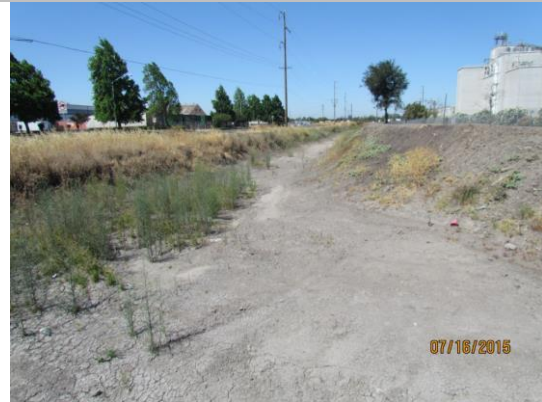
Photo 1 of 1 : CH\_2015\_NA0017\_42\_96\_20150819\_00067.jpg

Rating **	A	Issue No.	96	GPS Lat/Long
Issue Type +	Ma	Location *		37.908433 °
Category	Rivers, Channels & Designated Flood			-121.269214 °
Item	Vegetation & Obstructions			
DWR ID	DWR_NA0017_42_c _ 2012_96			
Action/Comments				
Inspector Comments: The flow is not impeded.

View of the channel looking downstream.

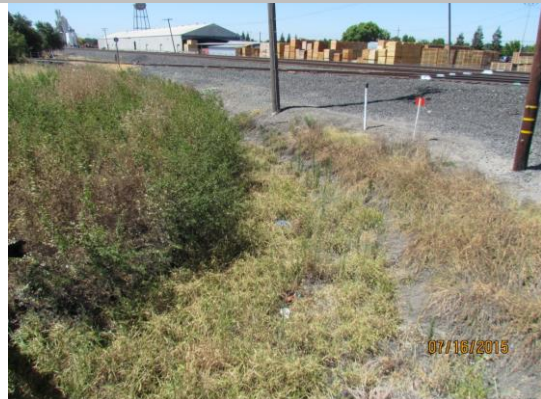
Photo 1 of 1 : CH\_2015\_NA0017\_42\_106\_20150819\_00069.jpg

Inspector Comments: Vegetation and debris may impede the flow of the channel.

View of the vegetation looking downstream of the channel.

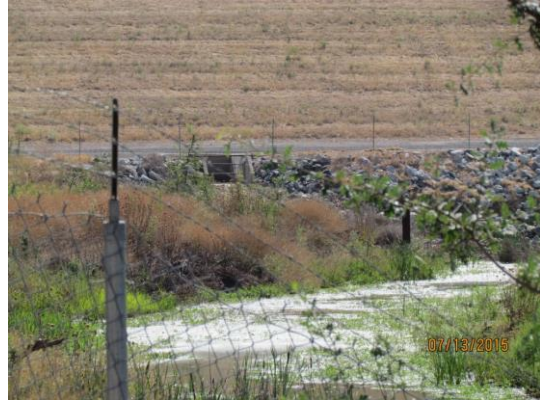
Photo 1 of 1 : CH\_2015\_NA0017\_44\_119\_20150817\_00051.jpg

Rating **	A	Issue No.	119	GPS Lat/Long
Issue Type +	Ma	Location *		37.900580 °
Category	Rivers, Channels & Designated Flood			-120.936018 °
Item	Gates			
DWR ID	DWR_NA0017_44_c_2014_119			
Action/Comments				
Inspector Comments: The gate appears to be functional.

View of the release gate from Farmington Dam looking upstream of the creek.

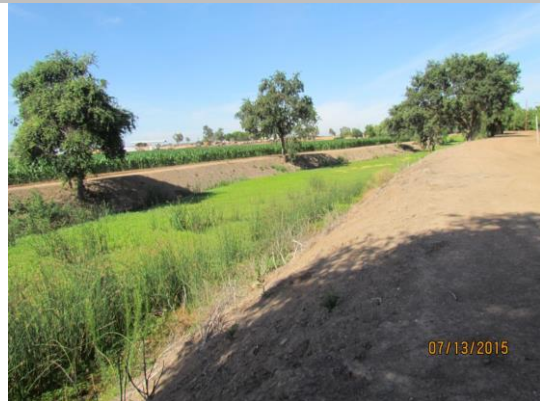
Photo 1 of 1 : CH\_2015\_NA0017\_44\_6\_20150817\_00052.jpg

Rating **	A	Issue No.	6	GPS Lat/Long
Issue Type +	Ma	Location *		37.900875 °
Category	Rivers, Channels & Designated Flood			-120.934847 °
Item	Vegetation & Obstructions			
DWR ID	DWR_NA0017_44_c_2012_6			
Action/Comments				
Inspector Comments: Minimal vegetation was present on the channel. The flow is not impeded.

View of the vegetation on the channel looking downstream.

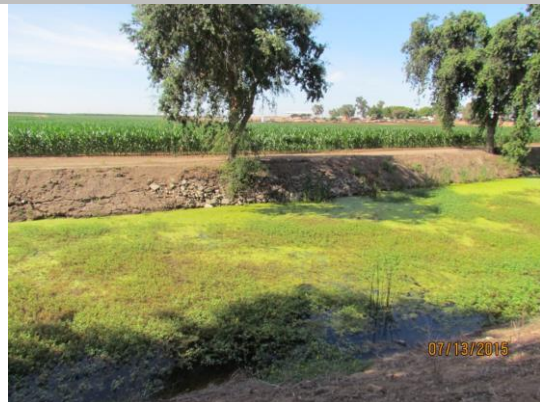
Photo 1 of 2 : CH\_2015\_NA0017\_44\_9\_20150817\_00054.jpg

Rating **	A	Issue No.	9	GPS Lat/Long
Issue Type +	Ma	Location *		37.900914 °
Category	Rivers, Channels & Designated Flood			-120.934604 °
Item	Revetments			
DWR ID	DWR_NA0017_44_c_2012_9			
Action/Comments				
Inspector Comments: Existing riprap appeared to be maintained.

View of the existing revetments looking downstream during 2015 inspection.

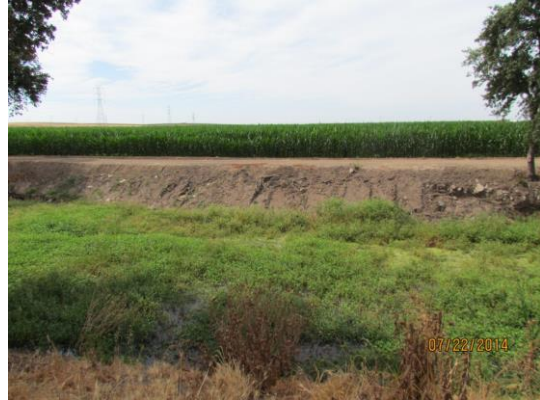
Photo 2 of 2 : CH\_2015\_NA0017\_44\_9\_20150710\_00005.jpg

Check Point / View				
Farmington Dam / Down (cont)				
Rating **	A	Issue No.	9 (cont)	GPS Lat/Long
Issue Type +	Ma	Location *		37.900914
Category	Rivers, Channels & Designated Flood			-120.934604
Item	Revetments			
DWR ID	DWR_NA0017_44_c_2012_9			
Action/Comments				
Inspector Comments: Existing riprap appeared to be maintained.

Existing revetments were covered by soil and appeared to be holding in place. The picture was taken looking upstream of the channel during 2014 inspection.

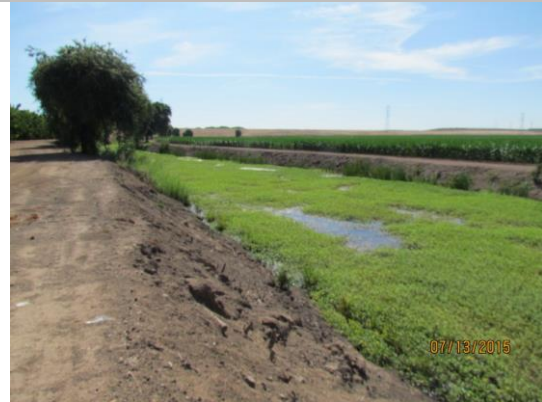
Photo 1 of 1 : CH\_2015\_NA0017\_44\_99\_20150817\_00055.jpg

Inspector Comments: Minimal vegetation may not impede the flow of the channel.

View of the vegetation on the channel looking upstream.

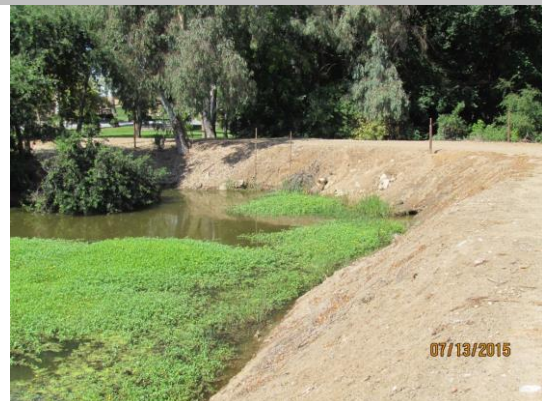
Photo 1 of 2 : CH\_2015\_NA0017\_44\_108\_20150818\_00056.jpg

Rating **	M	Issue No.	108	GPS Lat/Long
Issue Type +	Ma	Location *		37.900040 °
Category	Rivers, Channels & Designated Flood			-120.938949 °
Item	Gates			
DWR ID	DWR_NA0017_44_c_2013_108			
Action/Comments				
Inspector Comments: The pipe appeared to be in good condition, but accumulated debris may block the flow inside the pipe.

View of the pipe looking upstream of the channel during 2015 inspection.

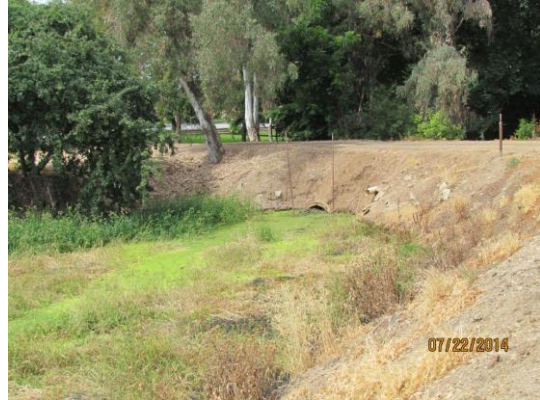
Photo 2 of 2 : CH\_2015\_NA0017\_44\_108\_20150710\_00046.jpg

Inspector Comments: The pipe appeared to be in good condition, but accumulated debris may block the flow inside the pipe.

View of the gate looking upstream of the channel during 2014 inspection.

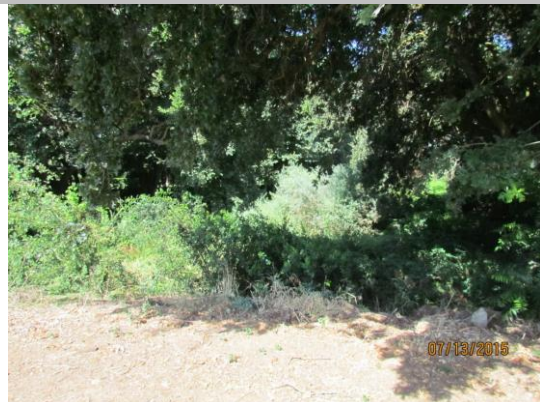
Photo 1 of 2 : CH\_2015\_NA0017\_44\_104\_20150818\_00057.jpg

Inspector Comments: Heavy vegetation growth will impede the flow and may block approximately 50% capacity of the channel.

View of the vegetation on the downstream of the channel during 2015 inspection.

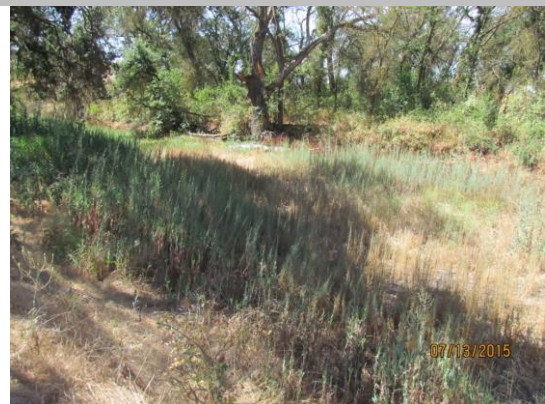
Photo 1 of 1 : CH\_2015\_NA0017\_44\_141\_20150818\_00058.jpg

Inspector Comments: Minimal vegetation was present, but the flow is not impeded.

View of vegetation on the upstream of the channel.

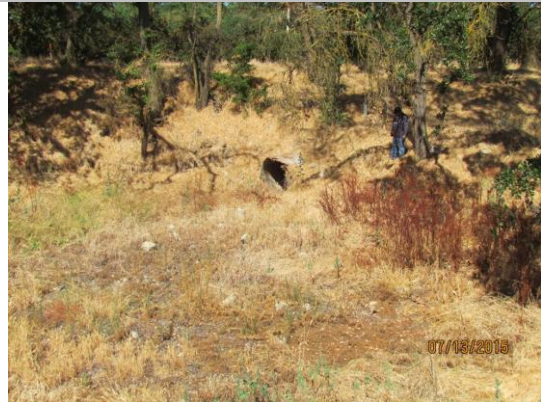
Photo 1 of 1 : CH\_2015\_NA0017\_44\_150\_20150824\_00092.jpg

Inspector Comments: The pipe appears to be not restricted and it will not impede the flow of the channel.

View of the pipe looking upstream from the channel.

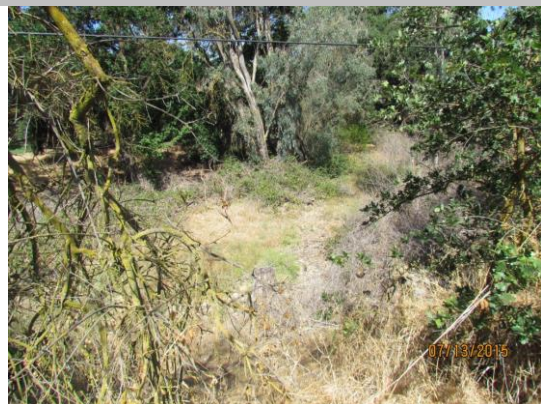
Photo 1 of 1 : CH\_2015\_NA0017\_44\_146\_20150818\_00060.jpg

Inspector Comments: Vegetation growth may impede the flow of the channel.

View of the vegetation on the downstream of the channel.

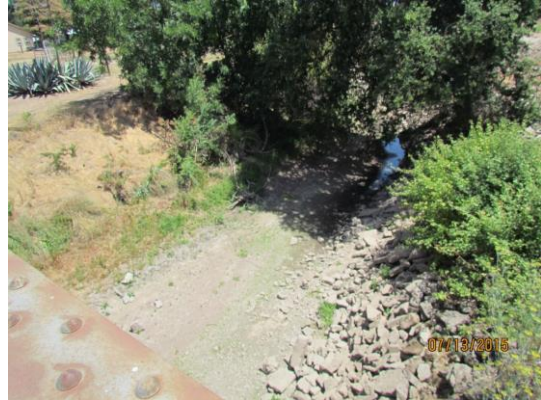
Photo 1 of 2 : CH\_2015\_NA0017\_44\_21\_20150818\_00061.jpg

Inspector Comments: No vegetation was impeding the flow of the channel.

View of the channel looking upstream during 2015 inspection.

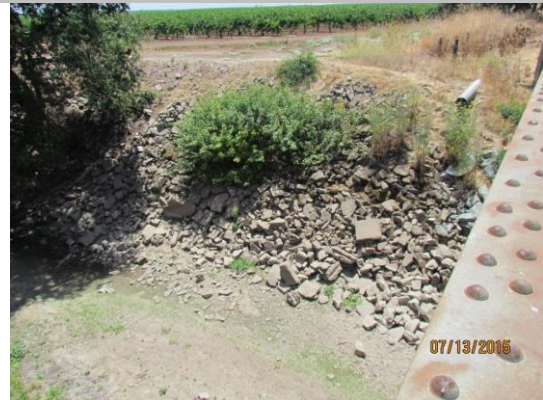
Photo 1 of 2 : CH\_2015\_NA0017\_44\_24\_20150818\_00062.jpg

Rating **	A	Issue No.	24	GPS Lat/Long
Issue Type +	Ma	Location *		37.925330
Category	Rivers, Channels & Designated Flood			-121.000120
Item	Revetments			
DWR ID	DWR_NA0017_44_c _ 2012_24			
Action/Comments				
Inspector Comments: Existing riprap is properly maintained.

View of the revetments looking upstream during 2015 inspection.

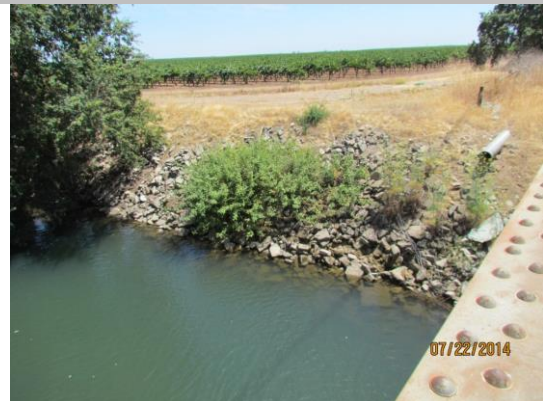
Photo 2 of 2 : CH\_2015\_NA0017\_44\_24\_20150710\_00009.jpg

Existing revetments are properly maintained looking upstream of the channel.

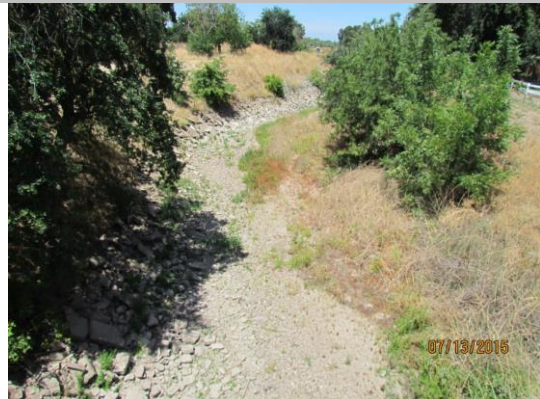
Photo 1 of 2 : CH\_2015\_NA0017\_44\_26\_20150818\_00063.jpg

Check Point / View				
Escalon Bellota Rd / Down				
Rating **	A	Issue No.	26	GPS Lat/Long
Issue Type +	Ma	Location *		37.925330 °
Category	Rivers, Channels & Designated Flood			-121.000120 °
Item	Vegetation & Obstructions			
DWR ID	DWR_NA0017_44_c _ 2012_26			
Action/Comments				
Inspector Comments: No vegetation was found on the channel.

View of the channel looking downstream during 2015 inspection.

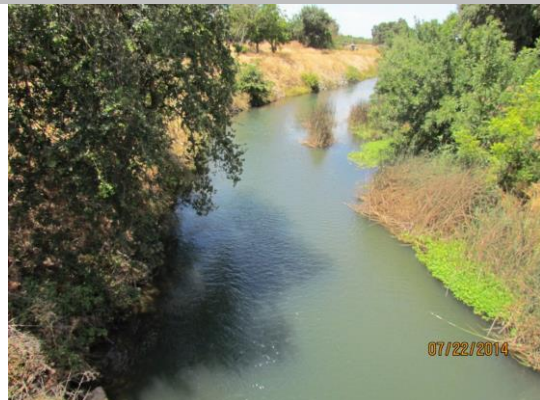
Photo 2 of 2 : CH\_2015\_NA0017\_44\_26\_20150710\_00010.jpg

View of the channel looking downstream.

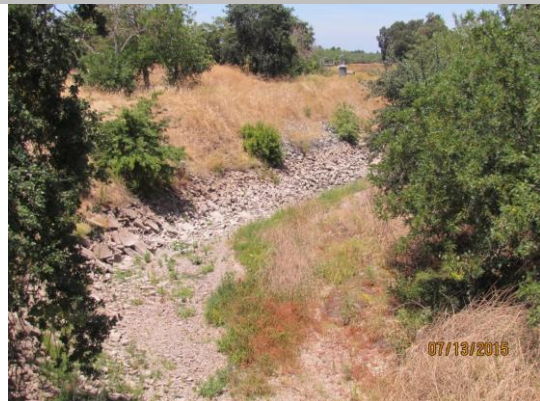
Photo 1 of 2 : CH\_2015\_NA0017\_44\_29\_20150818\_00064.jpg

Rating **	A	Issue No.	29	GPS Lat/Long
Issue Type +	Ma	Location *		37.925330 °
Category	Rivers, Channels & Designated Flood			-121.000120 °
Item	Revetments			
DWR ID	DWR_NA0017_44_c _ 2012_29			
Action/Comments				
Inspector Comments: Existing riprap is properly maintained.

View of the revetments on the left of the channel looking downstream.

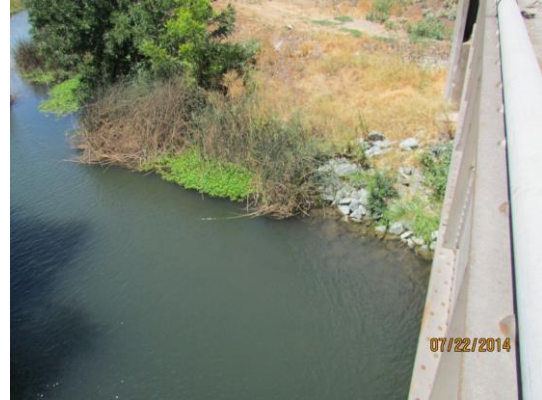
Photo 2 of 2 : CH\_2015\_NA0017\_44\_29\_20150710\_00012.jpg

Check Point / View				
Escalon Bellota Rd / Down (cont)				
Rating **	A	Issue No.	29 (cont)	GPS Lat/Long
Issue Type +	Ma	Location *		37.925330 °
Category	Rivers, Channels & Designated Flood			-121.000120 °
Item	Revetments			
DWR ID	DWR_NA0017_44_c _ 2012_29			
Action/Comments				
Inspector Comments: Existing riprap is properly maintained.

View of the revetments on the right bank of channel looking downstream.

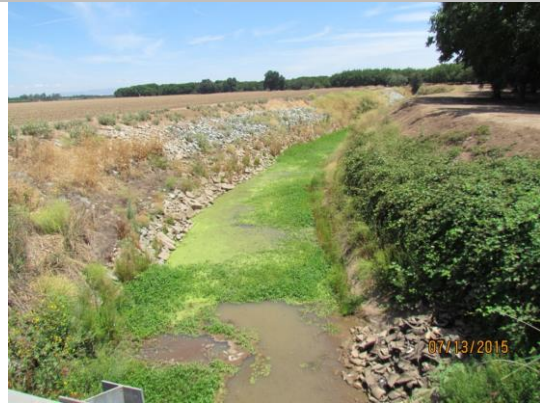
Photo 1 of 2 : CH\_2015\_NA0017\_44\_31\_20150818\_00065.jpg

View of the channel looking upstream during 2015 inspection.

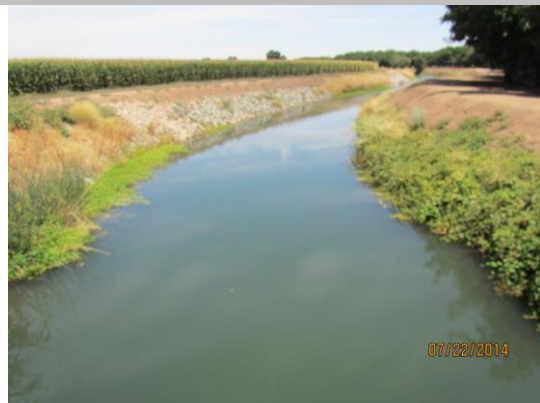
Photo 2 of 2 : CH\_2015\_NA0017\_44\_31\_20150710\_00013.jpg

View of the channel looking upstream during 2014 inspection.

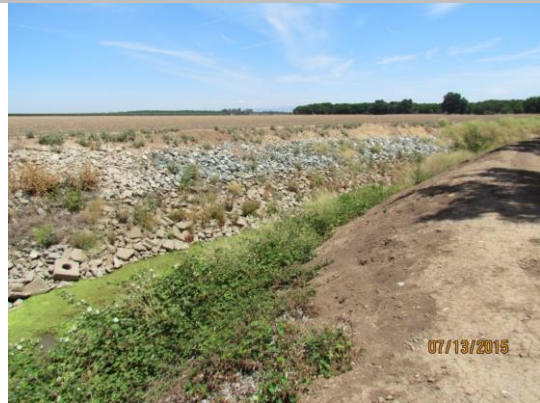
Photo 1 of 1 : CH\_2015\_NA0017\_44\_34\_20150818\_00066.jpg

Rating **	A	Issue No.	34	GPS Lat/Long
Issue Type +	Ma	Location *		37.920060 °
Category	Rivers, Channels & Designated Flood			-121.027790 °
Item	Revetments			
DWR ID	DWR_NA0017_44_c _ 2012_34			
Action/Comments				
Inspector Comments: Existing revetments were maintained properly on the channel bank.

View of the existing revetments on the channel bank looking upstream.

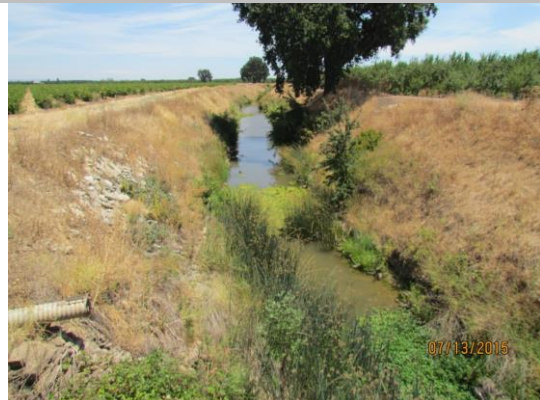
Photo 1 of 1 : CH\_2015\_NA0017\_44\_41\_20150818\_00068.jpg

Inspector Comments: Minimal vegetation growth is present on the channel.

View of the vegetation on the channel looking upstream.

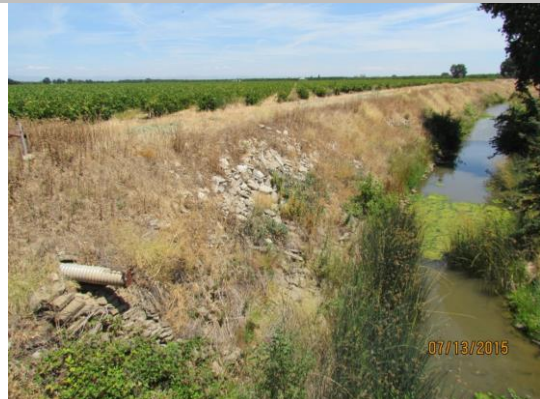
Photo 1 of 1 : CH\_2015\_NA0017\_44\_44\_20150818\_00069.jpg

Inspector Comments: Existing riprap protection is properly maintained.

View of the revetments on the channel bank looking upstream.

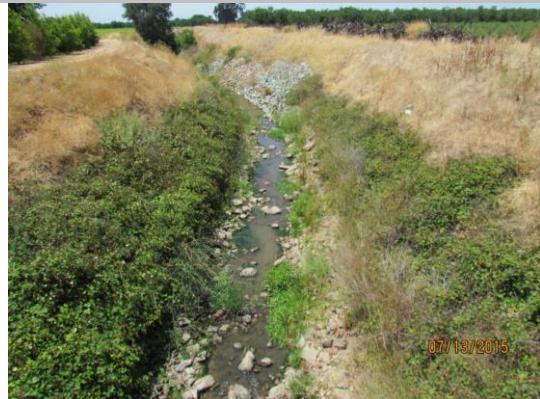
Photo 1 of 1 : CH\_2015\_NA0017\_44\_46\_20150818\_00070.jpg

Check Point / View				
Van Allen Rd / Down				
Rating **	A	Issue No.	46	GPS Lat/Long
Issue Type +	Ma	Location *		37.913060 °
Category	Rivers, Channels & Designated Flood			-121.056230 °
Item	Vegetation & Obstructions			
DWR ID	DWR_NA0017_44_c _ 2012_46			
Action/Comments				
Inspector Comments: The vegetation growth around the channel is not impeding the flow.

View of the channel looking downstream.

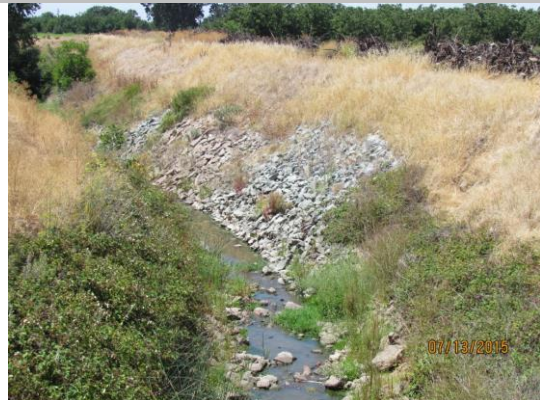
Photo 1 of 1 : CH\_2015\_NA0017\_44\_49\_20150818\_00071.jpg

Inspector Comments: Existing riprap protection is properly maintained.

View of the existing revetments looking downstream.

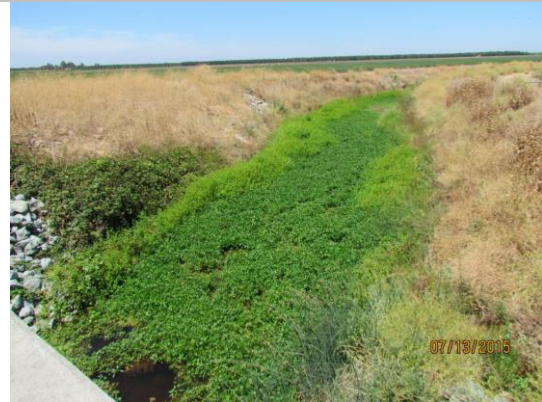
Photo 1 of 1 : CH\_2015\_NA0017\_44\_51\_20150818\_00072.jpg

Inspector Comments: Minimal vegetation is present in the channel.

View of the vegetation on the upstream of the channel.

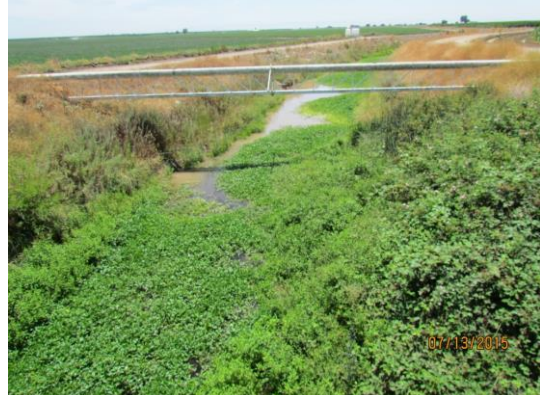
Photo 1 of 1 : CH\_2015\_NA0017\_44\_56\_20150818\_00073.jpg

Mariposa Rd / Down				
Rating **	M	Issue No.	56	GPS Lat/Long
Issue Type +	Ma	Location *		37.895050 °
Category	Rivers, Channels & Designated Flood			-121.118200 °
Item	Vegetation & Obstructions			
DWR ID	DWR_NA0017_44_c _ 2012_56			
Action/Comments				
Inspector Comments: Minimal vegetation and some woddy vegetation on the bank may impede the flow of the channel.

View of the vegetation on the channel looking downstream.

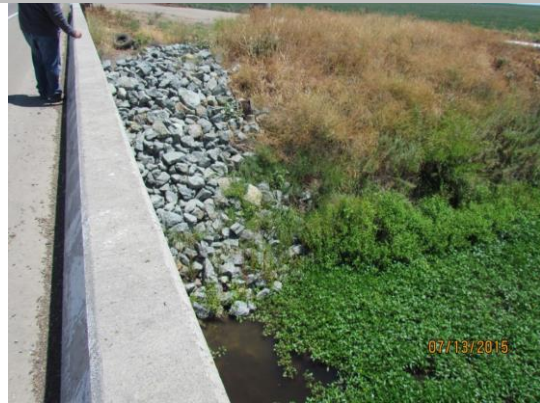
Photo 1 of 1 : CH\_2015\_NA0017\_44\_59\_20150818\_00074.jpg

Inspector Comments: Existing revetments appears to be undamaged.

View of existing revetments on the channel banks looking downstream.

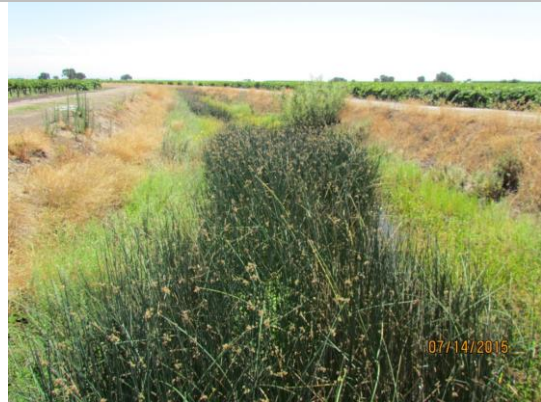
Photo 1 of 1 : CH\_2015\_NA0017\_44\_61\_20150818\_00075.jpg

Rating **	M	Issue No.	61	GPS Lat/Long
Issue Type +	Ma	Location *		37.880726 °
Category	Rivers, Channels & Designated Flood			-121.146929 °
Item	Vegetation & Obstructions			
DWR ID	DWR_NA0017_44_c _ 2012_61			
Action/Comments				
Inspector Comments: Cat tails are obstructing the flow of the channel.

View of the vegetation on the upstream of the channel.

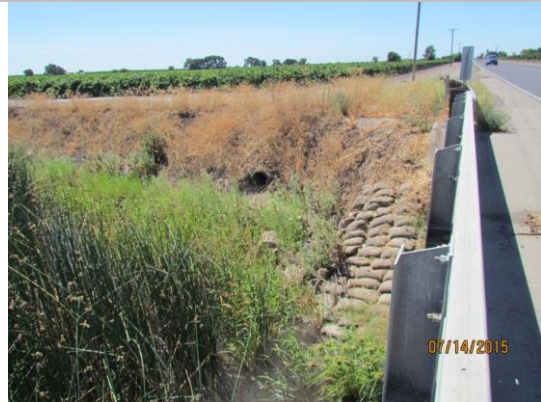
Photo 1 of 1 : CH\_2015\_NA0017\_44\_64\_20150818\_00076.jpg

Inspector Comments: Existing riprap protection is properly maintained.

View of existing riprap on the upstream of the channel.

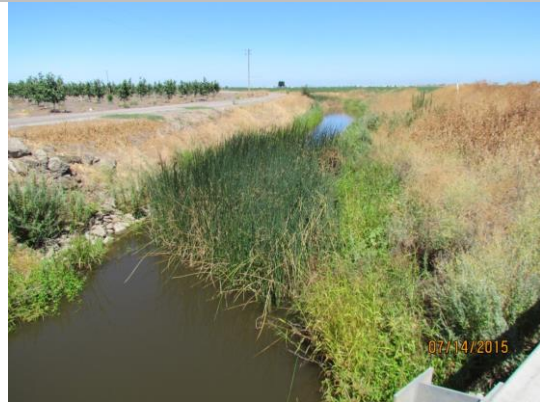
Photo 1 of 1 : CH\_2015\_NA0017\_44\_66\_20150818\_00077.jpg

Rating **	M	Issue No.	66	GPS Lat/Long
Issue Type +	Ma	Location *		37.880726 °
Category	Rivers, Channels & Designated Flood			-121.146929 °
Item	Vegetation & Obstructions			
DWR ID	DWR_NA0017_44_c _ 2012_66			
Action/Comments				
Inspector Comments: Vegetation may obstruct the flow of the channel.

View of the vegetation in the channel looking downstream.

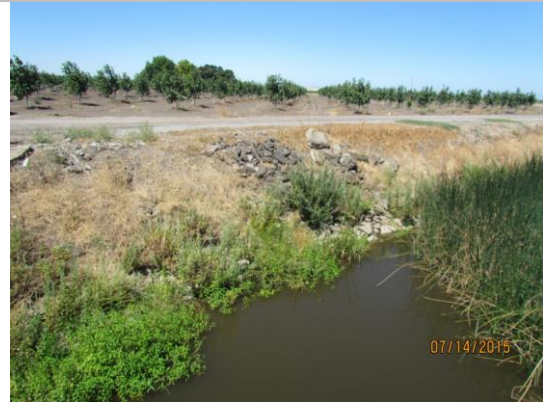
Photo 1 of 1 : CH\_2015\_NA0017\_44\_69\_20150818\_00078.jpg

Rating **	A	Issue No.	69	GPS Lat/Long
Issue Type +	Ma	Location *		37.880726 °
Category	Rivers, Channels & Designated Flood			-121.146929 °
Item	Revetments			
DWR ID	DWR_NA0017_44_c _ 2012_69			
Action/Comments				
Inspector Comments: Existing riprap protection is properly maintained.

View of the existing riprap on the channel bank looking downstream.

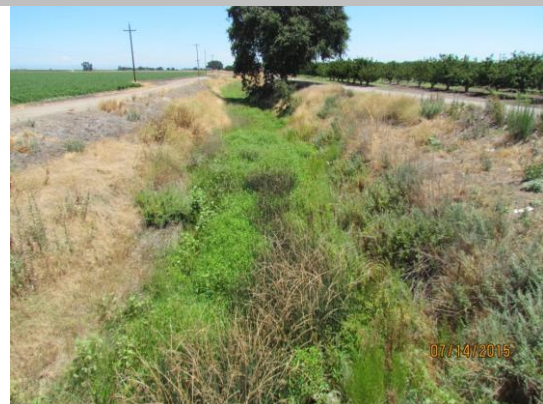
Photo 1 of 1 : CH\_2015\_NA0017\_44\_71\_20150818\_00080.jpg

Rating **	A	Issue No.	71	GPS Lat/Long
Issue Type +	Ma	Location *		37.872720 °
Category	Rivers, Channels & Designated Flood			-121.183100 °
Item	Vegetation & Obstructions			
DWR ID	DWR_NA0017_44_c _ 2012_71			
Action/Comments				
Inspector Comments: Minimal vegetation is present in the channel, but the flow is not impeded.

View of vegetation in the upstream the channel.

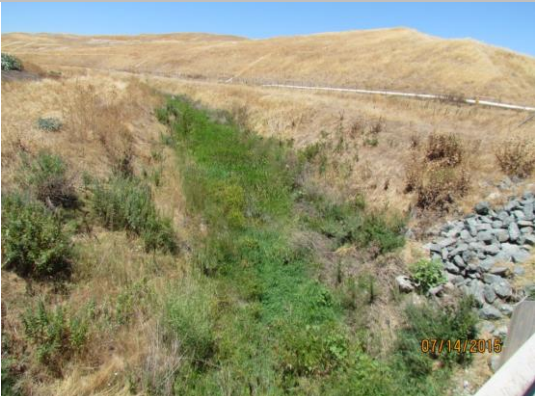
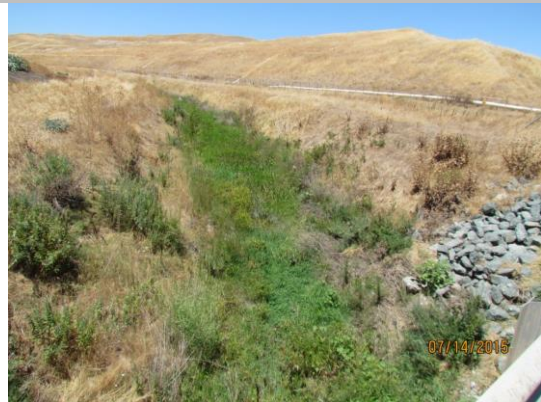
Photo 1 of 1 : CH\_2015\_NA0017\_44\_76\_20150818\_00081.jpg

Check Point / View				
Austin Rd / Down				
Rating **	A	Issue No.	76	GPS Lat/Long
Issue Type +	Ma	Location *		37.872720 °
Category	Rivers, Channels & Designated Flood			-121.183100 °
Item	Vegetation & Obstructions			
DWR ID	DWR_NA0017_44_c _ 2012_76			
Action/Comments				
Inspector Comments: Minimal vegetation growth is found, but it doesn't appear to impede the flow of the channel.

View of the vegetation on the downstream end of the channel.

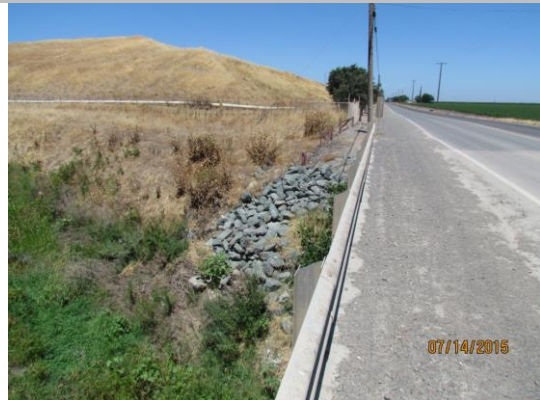
Photo 1 of 1 : CH\_2015\_NA0017\_44\_79\_20150818\_00082.jpg

View of the revetments on the downstream of the channel.

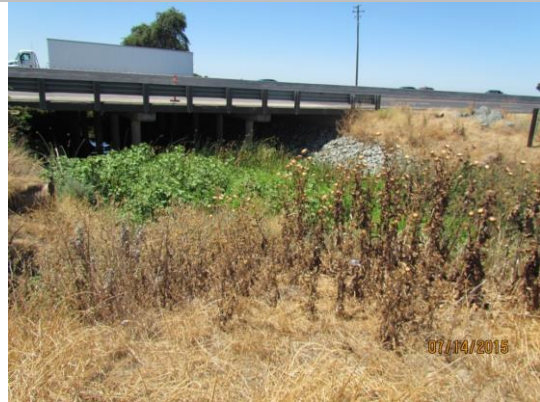
Photo 1 of 1 : CH\_2015\_NA0017\_44\_81\_20150818\_00083.jpg

Rating **	M	Issue No.	81	GPS Lat/Long
Issue Type +	Ma	Location *		37.872077 °
Category	Rivers, Channels & Designated Flood			-121.219318 °
Item	Vegetation & Obstructions			
DWR ID	DWR_NA0017_44_c _ 2012_81			
Action/Comments				
Inspector Comments: Vegetation growth may impede the flow of the channel.

View of vegetation on the upstream end of the channel.

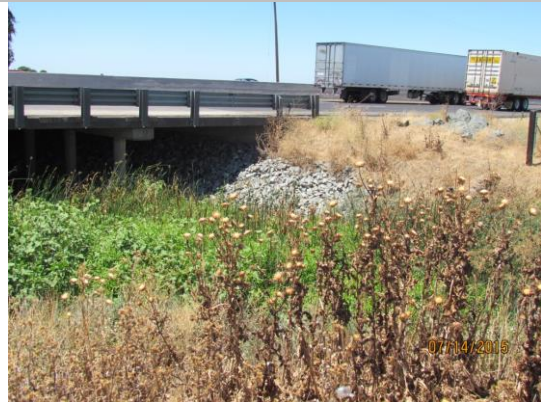
Photo 1 of 1 : CH\_2015\_NA0017\_44\_84\_20150818\_00085.jpg

Inspector Comments: Existing revetments were properly maintained at this location.

View of the existing revetments on the upstream end of the channel.

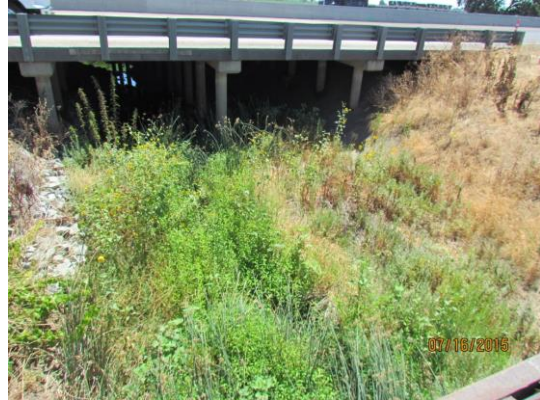
Photo 1 of 1 : CH\_2015\_NA0017\_44\_86\_20150818\_00088.jpg

Rating **	M	Issue No.	86	GPS Lat/Long
Issue Type +	Ma	Location *		37.872077 °
Category	Rivers, Channels & Designated Flood			-121.219318 °
Item	Vegetation & Obstructions			
DWR ID	DWR_NA0017_44_c _ 2012_86			
Action/Comments				
Inspector Comments: Minimal vegetation may impede the flow of the channel.

View of the vegetation looking downstream of the channel.
